**Tom na Clach Wind Farm  
Extension**

Appendix 11.B  
Bat Survey Report

<b>Client</b>	Nan Clach Extension Ltd
<b>Project</b>	Proposed Tom na Clach Wind Farm Extension
<b>Version</b>	FINAL
<b>Project number</b>	P20-227

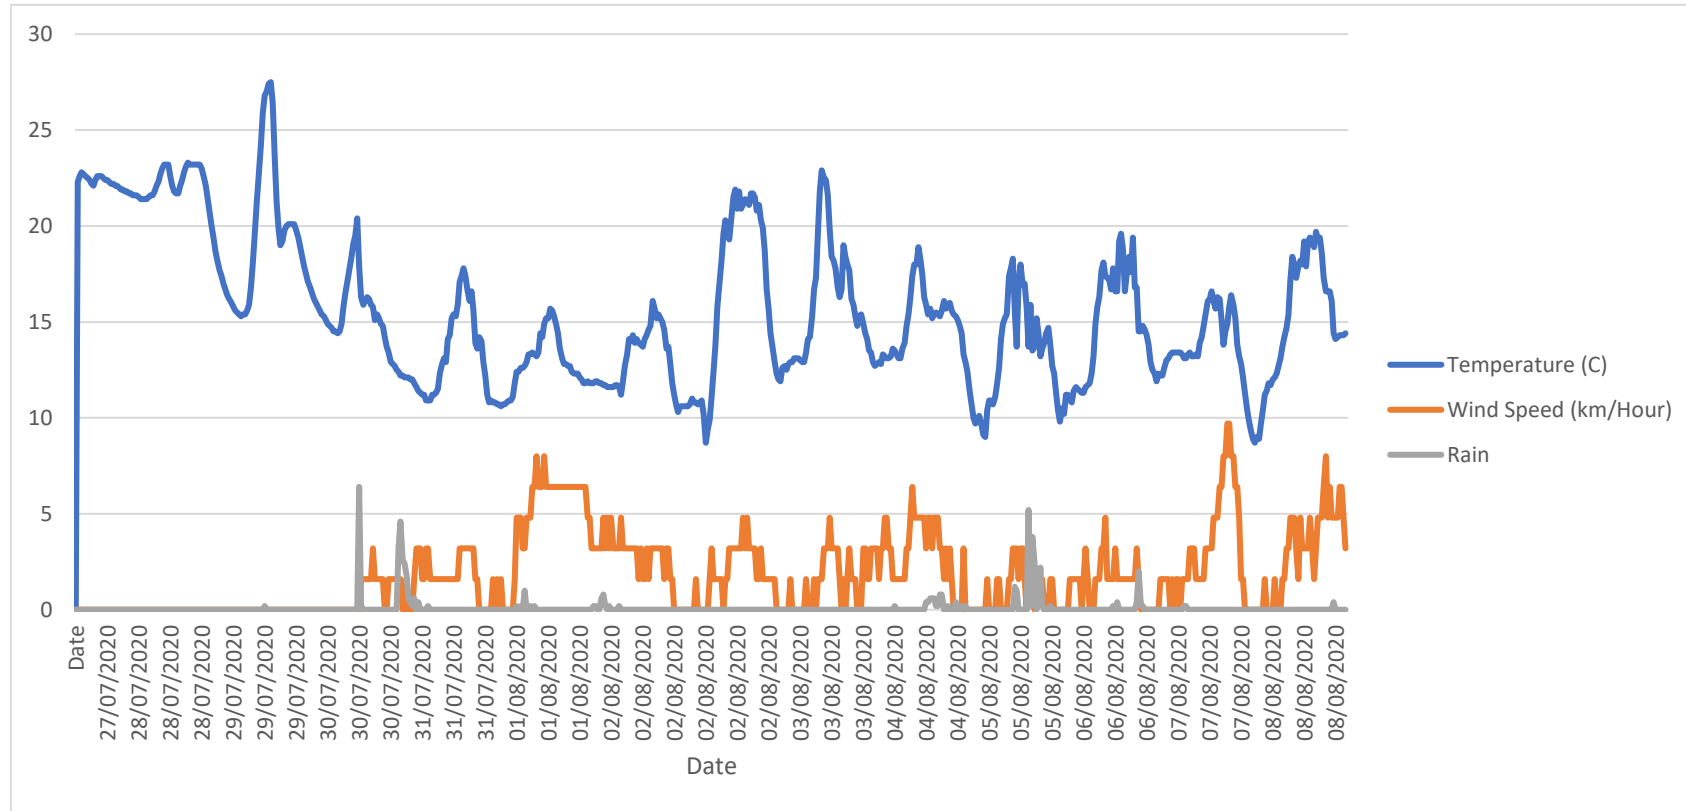
Graph 1: Weather Data for Survey Period 1

6.1 Rainfall, temperature and wind speed for each Survey Period is illustrated in Graphs 1-3 below.

- 3.9 Weather data are presented in Graphs 1-3 in Appendix 1. Conditions during Survey Period 1 remained optimal for bats throughout the survey period. Optimal conditions are considered to be temperatures of 10°C or higher at sunset, rainfall less than 5 mm per day and an average wind speed of less than 15 km/hour.

- 3.10 During Survey Period 2 temperatures were lower, falling within the range 7-10°C on several evenings. One period of higher wind speed was also recorded, and on this occasion the wind speed reached over 30 km/h for two days. These weather conditions are considered to be typical of the highland area of Scotland during the late summer / autumn period in which survey was undertaken<sup>2</sup>.

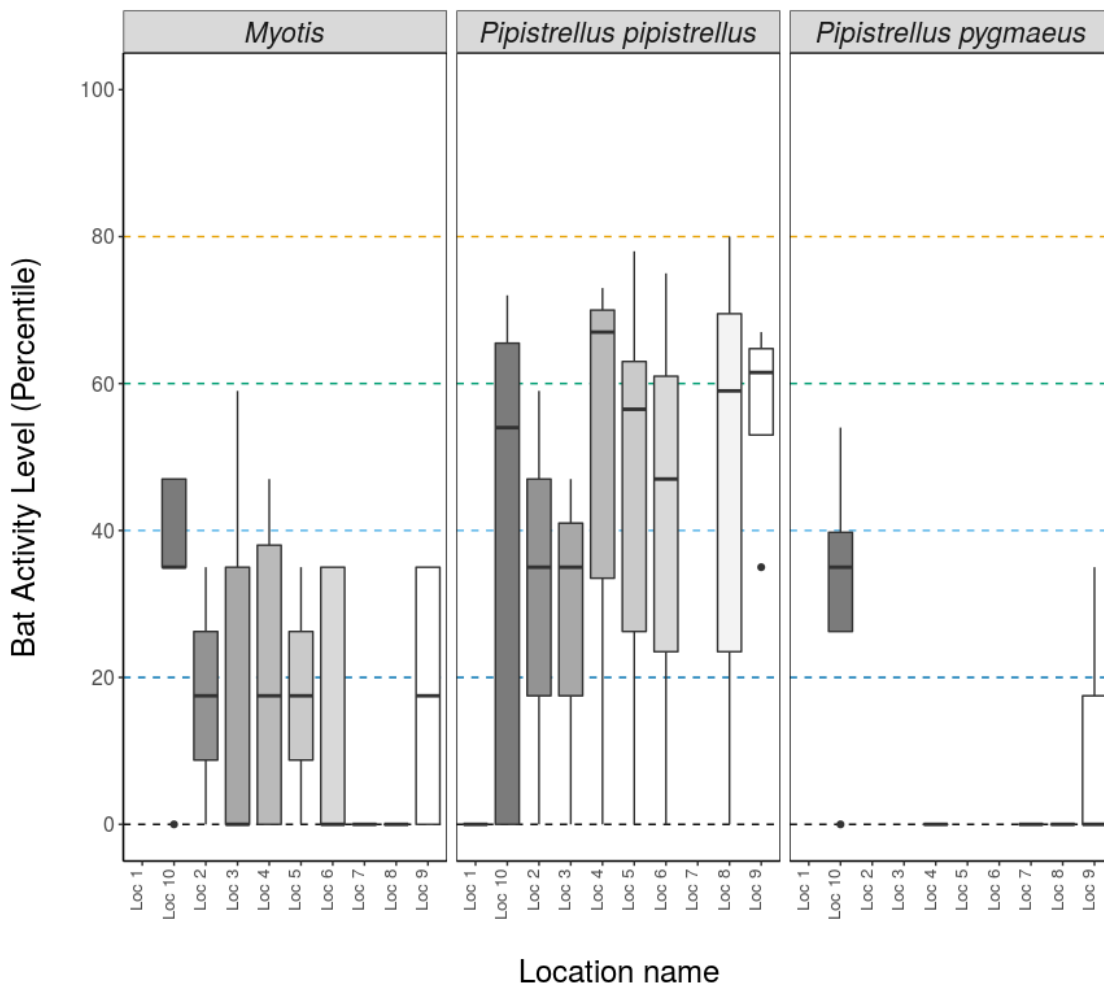
**Figure 1.** Differences in activity between static detector locations, split by species and location. The centre line indicates the median activity level whereas the box represents the interquartile range (the spread of the middle 50% of nights of activity)

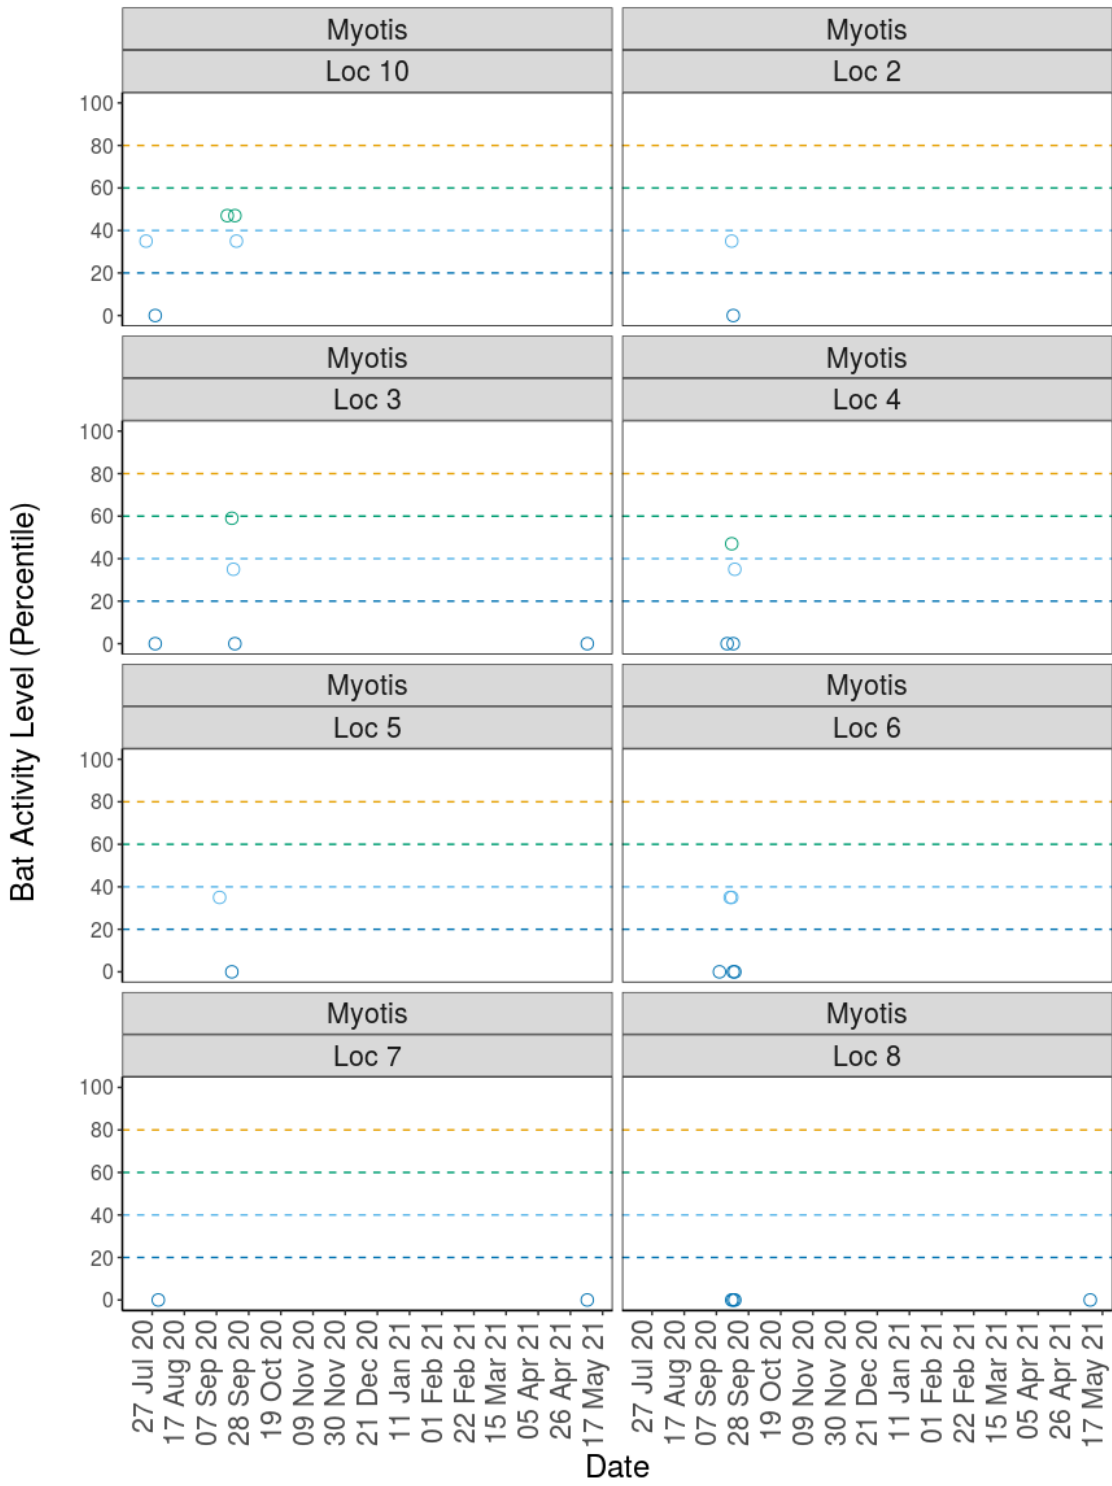
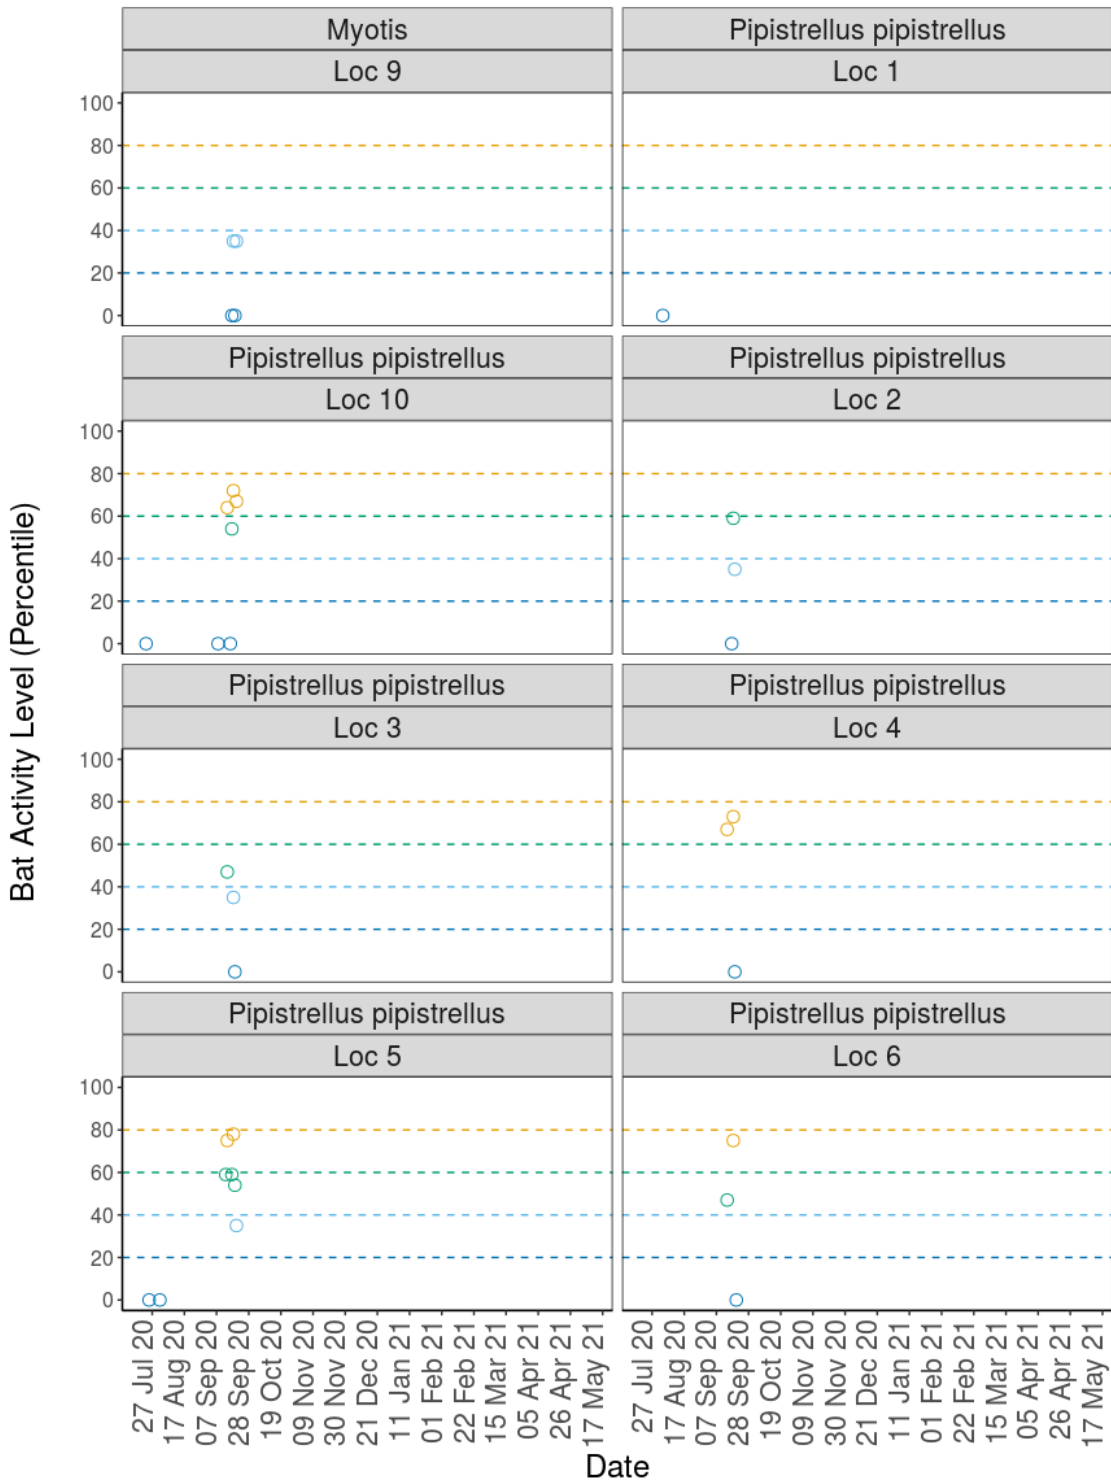
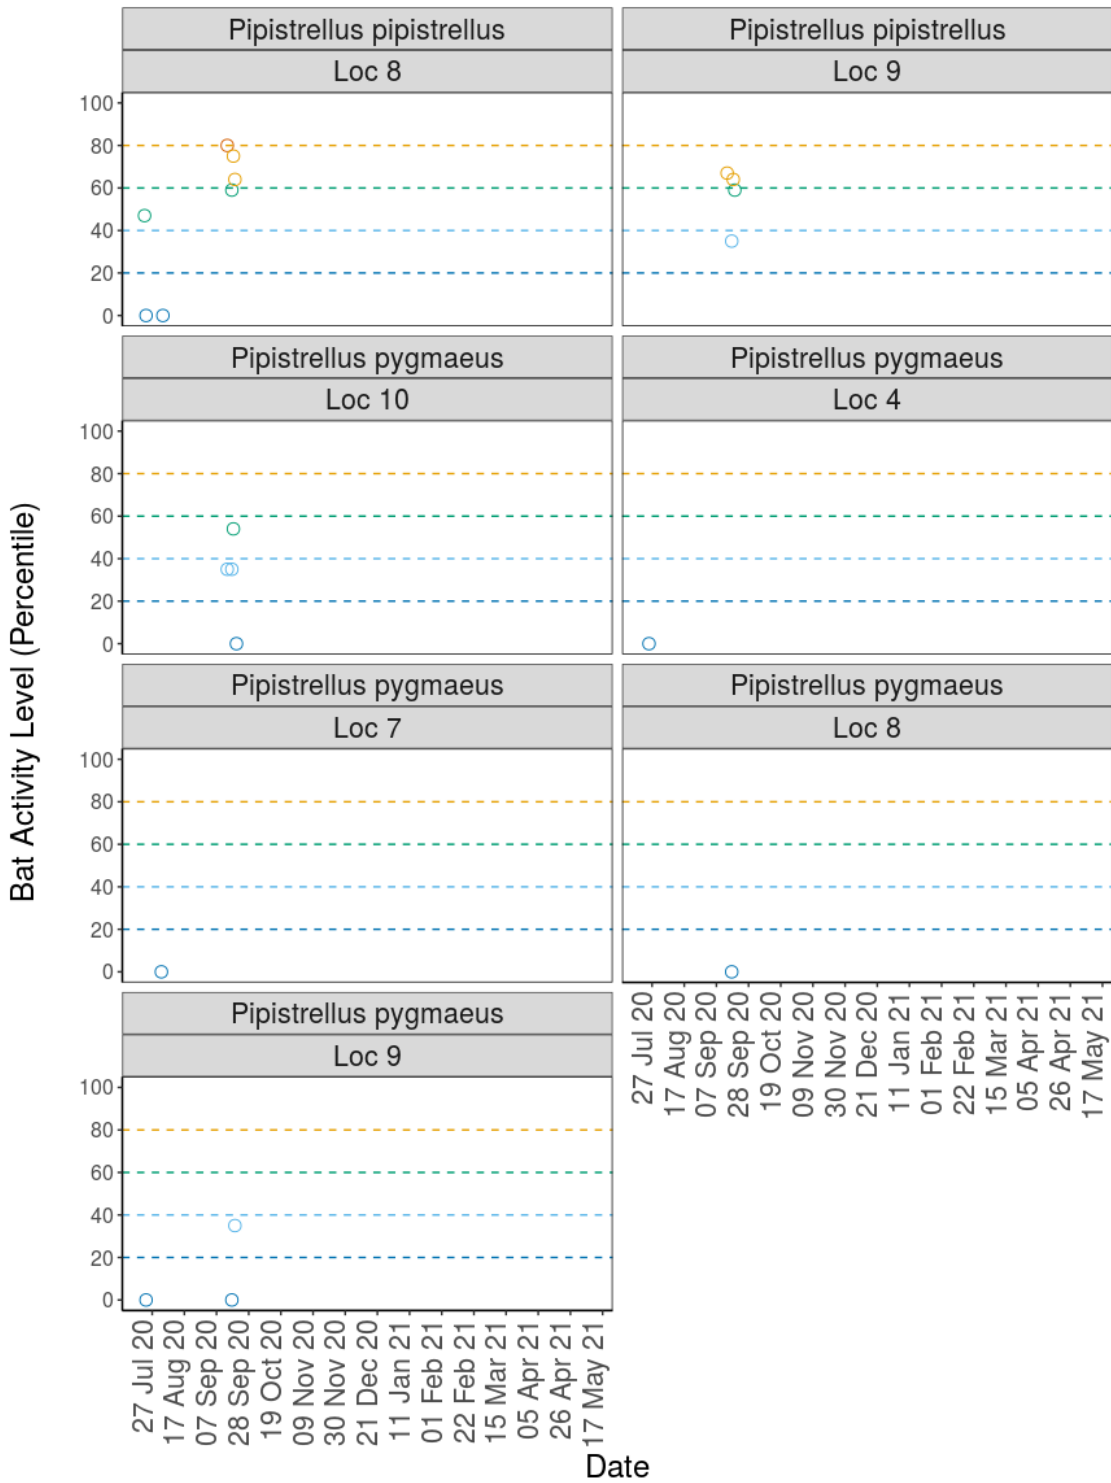
**Figure 2.** The activity level (percentile) of bats recorded across each night of the bat survey, split by location and species.
